## Icom R-75 Common Problem

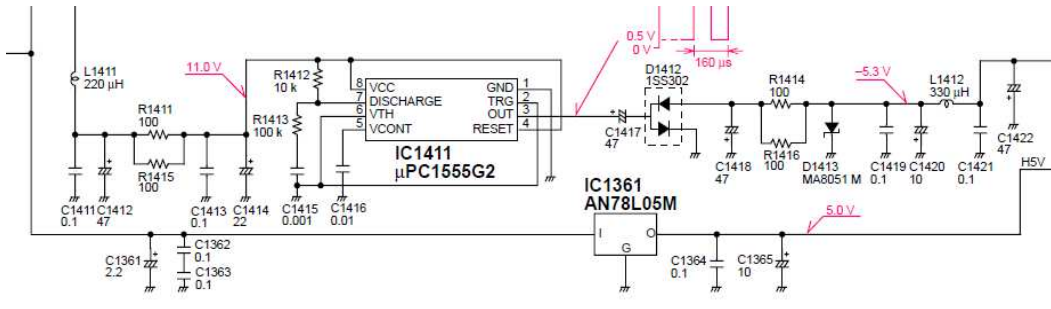
Two Icom R-75 general coverage receivers, one purchased new in 2007 (s/n 0203933) and the other purchased used in 2008 (s/n 02280), with identical problem. After receiver has been turned off for a while and then turned on, it is dead but after 10 minute warm-up it squeals and motorboats for up to another 15-20 minutes. After that, the receiver works fine but with what seems to be slightly weak audio output. The problem gets progressively worse over time. For example, one receiver would start to squeal almost immediately after turned on and require only a few minutes to start working but when tried a month or two later, it would require up to 30 minutes to start working.

The problem was traced to bad electrolytic capacitors C1412, C1417, C1418 and C1422 in the -5 V converter circuit (IC1411 in schematic below). The -5 V is used by many sub-circuits in the R-75.

These are SMD capacitors that have the same part number and require about 1 h to replace. The replacement part number is different than the original part number:

- ✓ Original Icom p/n 4510004640: Panasonic p/n ECEV1CA470SP, 47 µF, 16 V, 85 °C electrolytic
- ✓ Replacement Icom p/n 4510008520: Panasonic p/n EEE1CA470SP, 47 µF, 16 V, 85 °C electrolytic

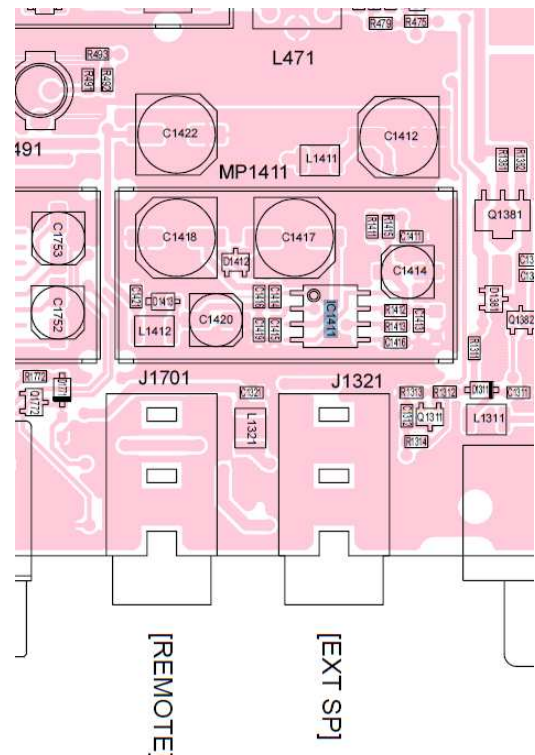
The capacitors are on the Main Unit PCB near the back close to the EXT SP and REMOTE jacks (see layout right). C1417 and C1418 are inside the converter shield and C1412 and C1422 are outside adjacent to the shield.
