Icom R-75 Common Problem

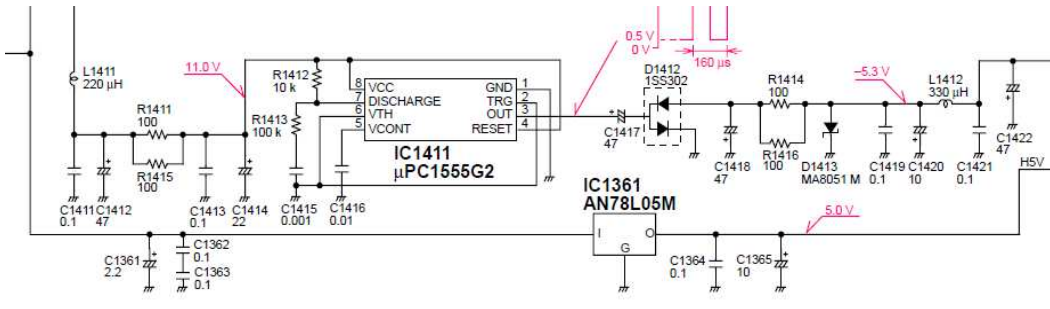
The problem was traced to bad electrolytic capacitors C1412, C1417, C1418 and C1422 in the -5 V converter circuit (IC1411 in schematic below). The -5 V is used by many sub-circuits in the R-75.

These are SMD capacitors that have the same part number and require about 1 h to replace. The replacement part number is different than the original part number:

- ✓ Original Icom p/n 4510004640: Panasonic p/n ECEV1CA470SP, 47 µF, 16 V, 85 °C electrolytic
- ✓ Replacement Icom p/n 4510008520: Panasonic p/n EEE1CA470SP, 47 µF, 16 V, 85 °C electrolytic

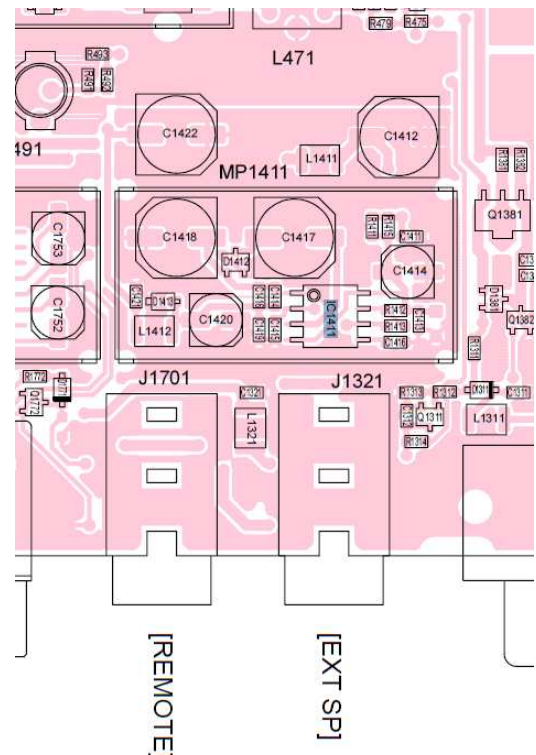
The capacitors are on the Main Unit PCB near the back close to the EXT SP and REMOTE jacks (see layout right). C1417 and C1418 are inside the converter shield and C1412 and C1422 are outside adjacent to the shield.
