# Overcoming Design Deficiencies in *RigRunner* DC Distribution Panels

Whitham D. Reeve

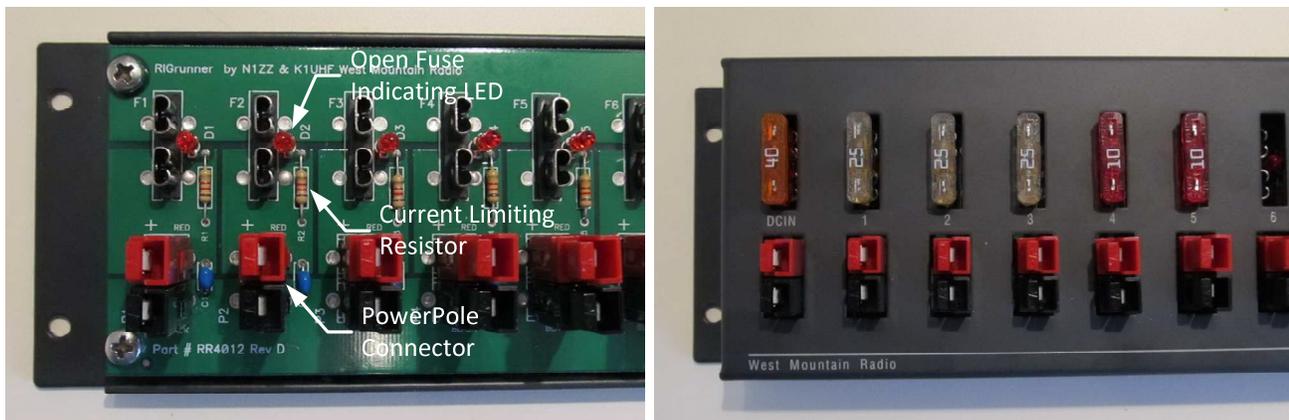
Each *RigRunner* circuit includes an LED blown-fuse indicator (figure 1) through which the circuit continues to be powered at reduced voltage even though the fuse has burned open due to overload or short circuit (flaw 1). The output voltage after the fuse has opened depends on the load. The blade fuses are fast-acting and have little tolerance to transients, which causes nuisance opening. With no load connected, full system voltage is measured with a digital multimeter (DMM) at the connector on the load side of an open fuse – a confusing indication to say the least.

The blown-fuse indicator LED glows when the fuse has opened, getting its current through the load and a 1200 ohm current limiting resistor. This assumes the load has sufficiently low impedance to allow enough current to flow to forward bias the LED. The LED is located on the internal PCB and hidden by the installed fuse (flaw 2). This has proven more of an annoyance than a safety problem (the resistor limits the current to 10 mA in a 12 V system).

Figure 1. Left: Cover removed from a *RigRunner* distribution panel. The blown-fuse indicator LEDs on the printed circuit board can be seen just to the right of and between the two fuse blade sockets. The 1200 ohm current limiting resistors are

visible below and to the right of the LEDs. Right: The LEDs are invisible under normal lighting conditions. A faint glow can be seen when a fuse blows and the ambient light is low. These images show early versions of the distribution panel with through-hole resistors and LEDs. Later versions use surface mounted devices (SMD).

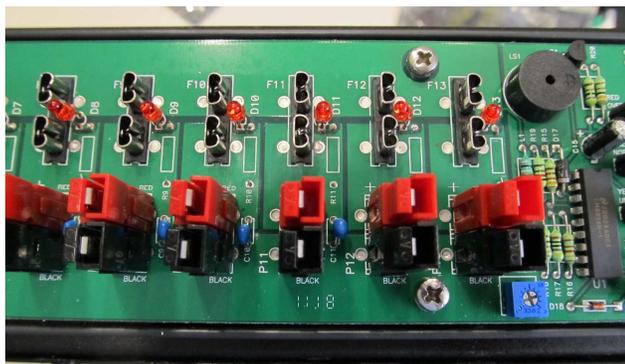
Figure 2. Removal of LED current limiting resistors (through-hole types). The resistor leads have been cut and the bodies discarded. Compare to left side of figure 1.

Flaw 1 and Flaw 2: Simply remove the LED current limiting resistor or LED from each circuit. I cut the through-hole resistor leads (figure 2). For the SMD resistors on the more recent panels, I cut the resistor body while heating one end with a soldering iron and then removed the other end. Since the LEDs cannot be seen anyway, nothing is lost but now the circuit will completely open if a fuse blows. Troubleshooting with a DMM will be much easier and much less confusing;

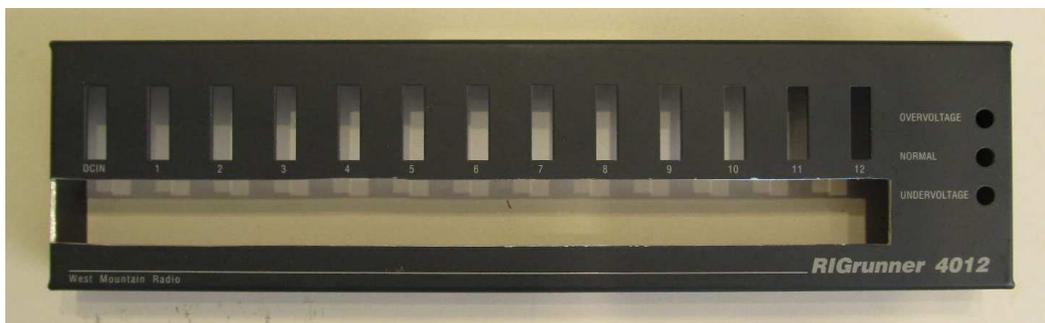
Figure 3. Cover for a 12-circuit distribution panel. The metal webs between the PowerPole connectors have been removed with a nibbler tool. The fuse slots are immediately above the cutout area. Compare to the right side of figure 1.

Flaw 3: Use a nibbler tool to cut the metal web on the cover between each PowerPole connector (figure 3). Also, notch out each end about 1/4 in (6 mm) to provide clearance for the retention clips on the end connectors.

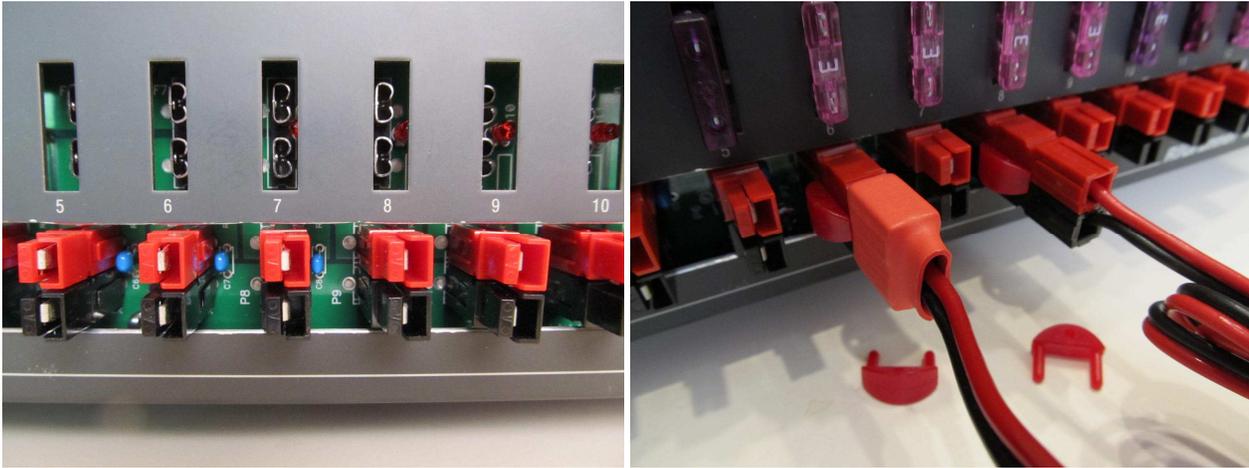
Figure 4. Left: Cover in place and modifications completed. Now, the retention clips can be inserted on either side to hold the connectors in place. Right: Retention clips in-place on two of the connectors with a couple extra clips immediately below. Only a little dexterity is needed to fit the clips, which securely hold the connectors in-place.

Place the cover in a vise with wood protecting blocks on the jaws and file the cuts smooth. Clean up metal dust and replace the cover (figure 4-left). Now, the retention clips can be inserted onto either side of the connectors (figure 4-right).
