Siting of SAM-III Magnetometer Sensors ~ Case Study

Whitham D. Reeve

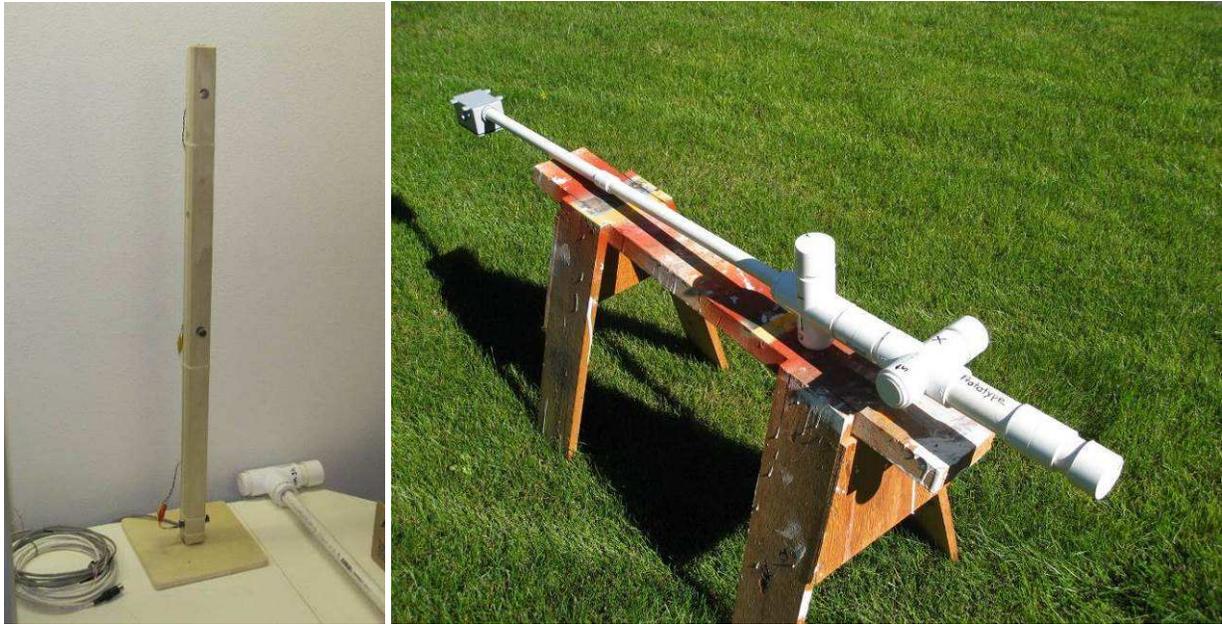
Figure 2 ~ Sensor fixtures. Left: Indoor lab sensor test fixture. The sensors are the small black objects spaced on the vertical wood stick, which is slightly < 1 m long. The X-axis sensor is located at the bottom, Y-axis is 300 mm above X, approximately in the middle, and Z-axis is 300 mm above Y at the top of the stick. The test fixture base is about 0.8 m above the lab baseboard heater and influenced by heat from it. Connections are made by clip-leads. Right: Outdoor sensor fixture posing on a sawhorse before burial in 2010. It was built using plastic DWV pipe and buried vertically so the middle sensor (the first perpendicular cylinder from the right) is about 1 m below the surface. The Z-axis is at the bottom (lower-right corner of the picture), X-axis above it (diagonally to the left in the picture) about 150 mm and Y-axis is closest to the surface and about 150 cm above X. The junction box for connecting the sensor cables is seen at the upper-left corner of the picture.

One set of three sensors is indoors and mounted in a laboratory test fixture (figure 2 and 3). This fixture may be moved around and the sensors are influenced by lab temperature variations and manmade magnetic disturbances from lab activity. The fixture was not moved during the measurements presented here. These sensors also are affected by magnetic variations due to vehicles moving in and out of the upper driveway about 15 m away and moving in and out of the upper garage about 5 m away. The lab test fixture is located about 2 m from its SAM-III controller and is used for live testing of SAM-III printed circuit boards.

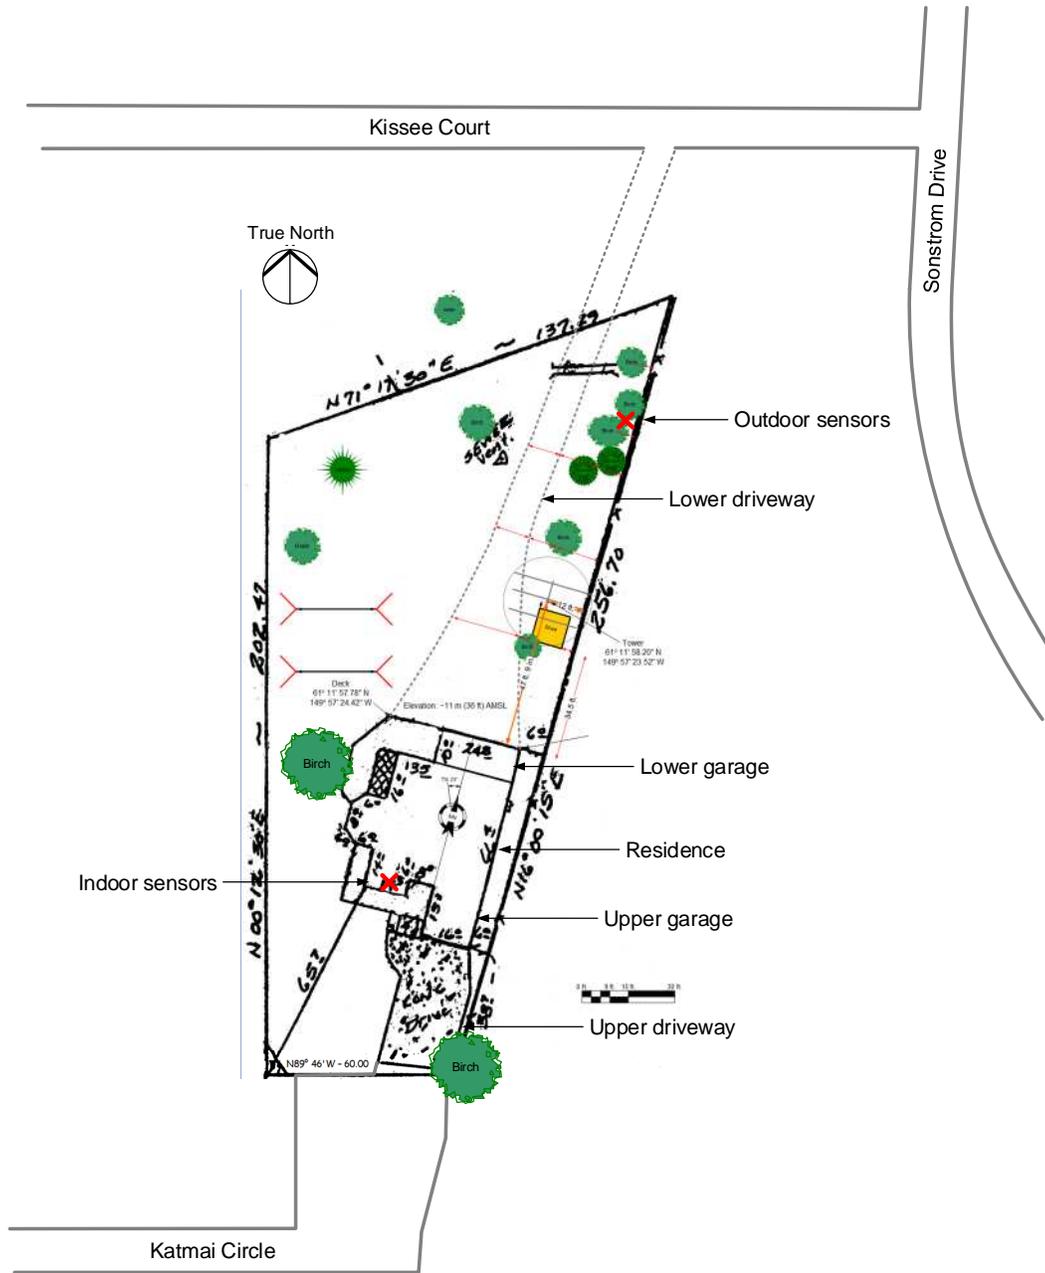
Figure 3 ~ Plat showing SAM-III sensor locations and other details. The permanently buried outdoor sensor fixture is indicated by the red X at upper-right of the trapezoidal property. The temporary indoor fixture is indicated by the red X at lower-middle of the plat, inside the residence. Property lines are thick black lines, and roads and driveways are thick gray lines. For reference, the eastern property line is 78.2 m (256.7 ft). Katmai Circle, Sonstrom Drive and Kissee Court are not built for through traffic and serve only a few local residences.
