CR-282 Oven Controlled Crystal Upgrade for the R-75 Receiver Whitham D. Reeve

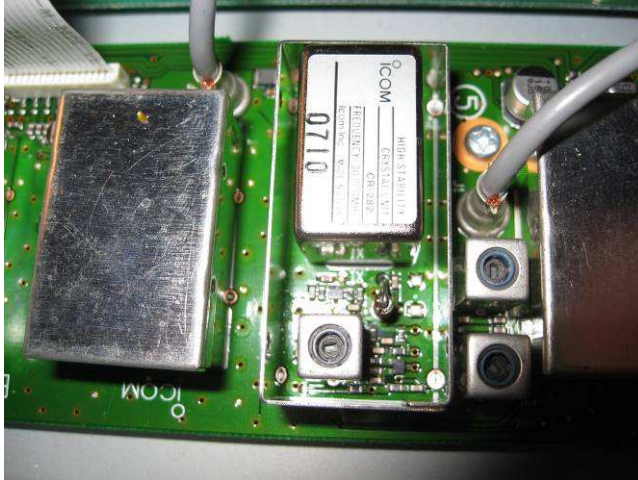
Figure 2 – New CR-282 Oven Controlled Crystal (top center of picture) installed in the oscillator fence after removal of the original CR-275A crystal. The CR-282 provides significantly higher frequency stability over a wider temperature range than the plain crystal it replaces and is recommended for mobile installations and fixed installations that require higher stability. The oscillator frequency is adjusted with L2, which is the variable inductor can below the new crystal.

The five screws holding the PLL board to the chassis must be removed and the board tilted upside down to gain access to the bottom for desoldering and soldering. There are several coaxial jumpers that connect the PLL board to the main board, but they do not have to be removed except the one for frequency measurements. I used a piece of tape as a third hand to hold the new crystal in place while I soldered it with a WD-1 soldering tool and 0.032 in. diameter Kester solder. The new crystal is shown in Figure 2.
